**SAVE SLATS & PADS
FROM WEAR!**

The **ARMOR-ROCK SYSTEM** from Vanberg Specialized Coatings provides an effective long-term solution.

VANBERG SPECIALIZED COATINGS

CONCRETE REPAIR & PROTECTION PRODUCTS

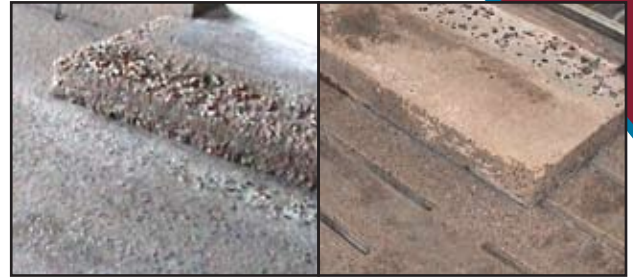
CONCRETE PADS

These were one of the earliest efforts to protect slats. And indeed they did just that. But only over the slats they covered. It was observed that soon the pad and the slat area immediately around (about a 1 ½ ft. area) the pad suffered from erosion from the corrosive compounds. Producers became faced with an extended wear area to deal with. Common Portland-based mortars have been tried to make repairs but found to be very temporary (usually one turn or less).

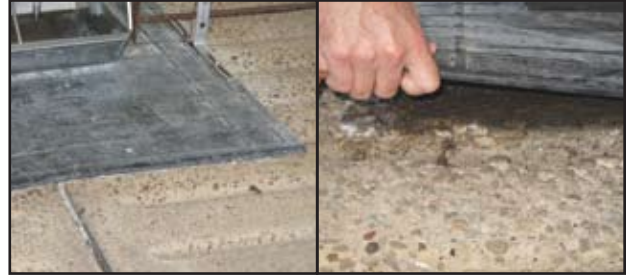
MATS

Mats have been used extensively to address the wear problems around the feeders since the early 1900's. Like pads, it was seen that the mats protect new slats immediately beneath the pads yet also displace corrosive compounds to the perimeter of the mat. This results in slat deterioration in an area of approximately 1 ½ ft. around the mat. Producers are now faced with restoring and protecting the area around the mat in addition to maintaining the mat. Producers also report difficulty with cleaning beneath the mat (especially if the mat is placed over eroded slats), keeping the mat anchored and slippery conditions that develop.

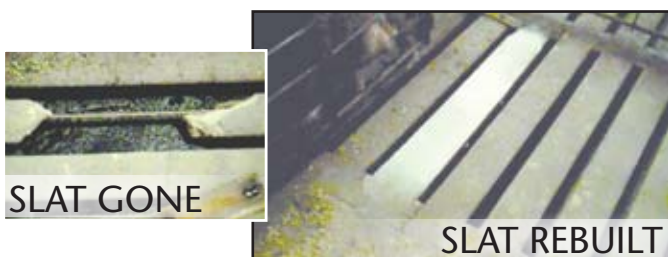
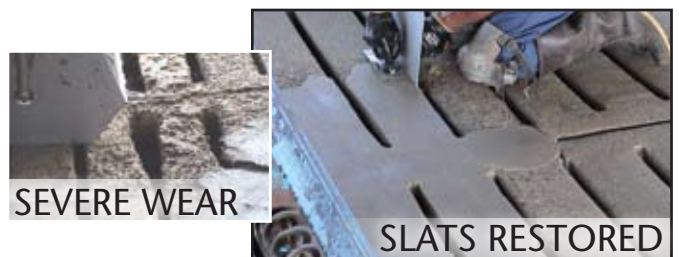
In some cases (considering time and cost constraints) slats and pads are not able to be easily replaced. Using products and techniques developed by Vanberg Specialized Coatings, virtually any severely eroded area can be restored quickly and permanently. Even wear down to the re-rod or slats that have lost entire sections or slats with extreme cracking can be fixed. Typically **CON-KORITE** pure-cement mortar or **ARMOR-GROUT** epoxy mortar will restore and level severely eroded areas.
